Manhole Inspection Summary

Manhole # S04EE2016MH

Insp Date: **7/13/06 9:08 AM**

Location Address: **3419 OLYMPIA AVE**

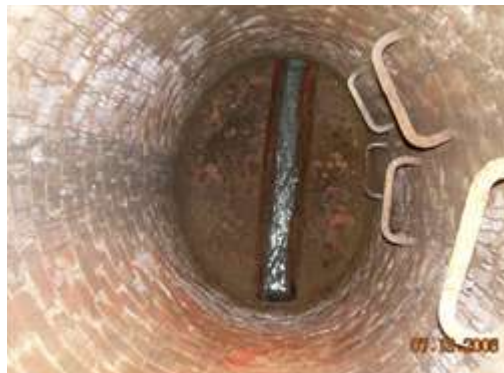
Top View

Adjustment and Barrel infiltration.
Corroded steps. Evidence of surcharge -
Bench debris.

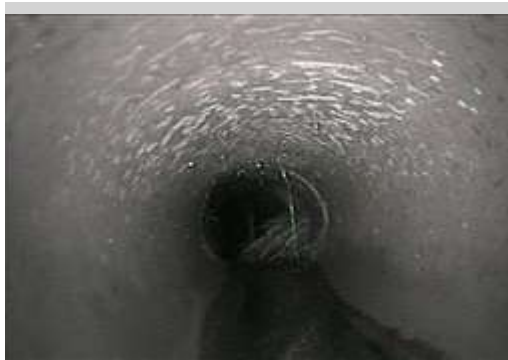
Defect

Root intrusion in O12

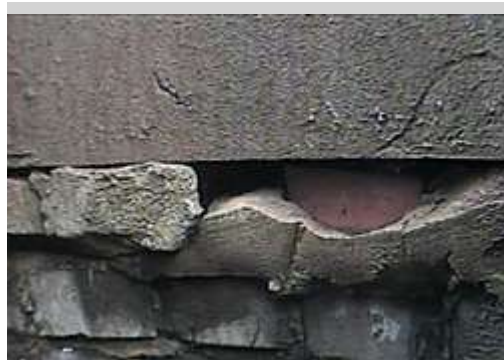
Defect

Frame leaks. Adjustment loose brick.
Adjustment infiltration.

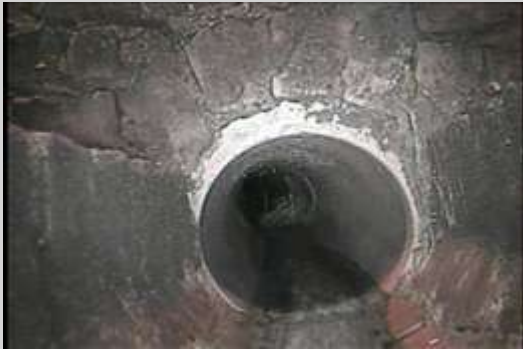
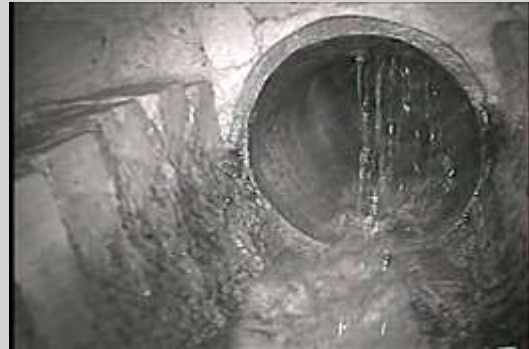
Pipe Out @ 12 O'Clock

Comments **The O12 pipe picture shows Channel leaks / mineral deposits - deterioration. The O12 pipe picture also shows inflow through the roof of the the pipe.**

Infiltration: **Evidence** Pipe Seal Cond: **Unknown**

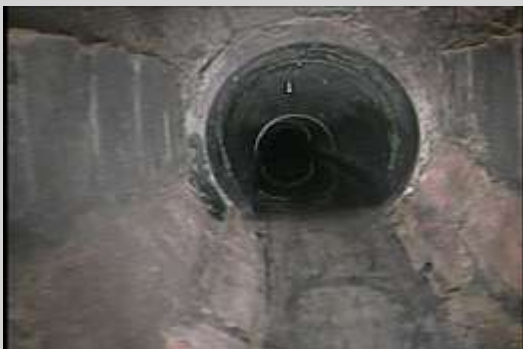
Pipe In @ 6 O'Clock

Infiltration: **Evidence** Pipe Seal Cond: **Unknown**
